CASE STUDY

How GHD used Video-Based Conflict Analysis to Diagnose Speeding & Inform Interchange Design in Rural California

Study Objective

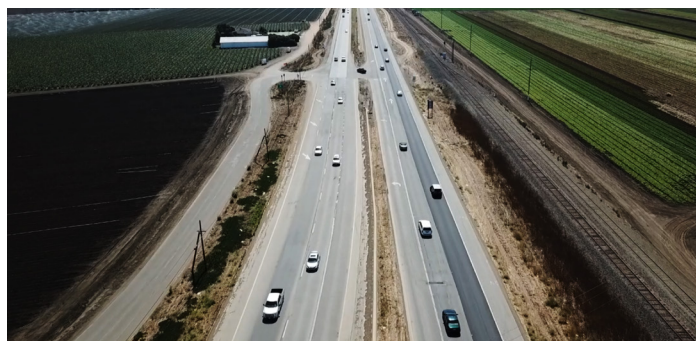
Figure 1. Drone view of US-101 courtesy of GHD

This section of US-101 offers two lanes in the northbound and southbound directions. Near the intersection, an extra two lanes are provided in each direction for northbound and southbound left and right turns. To the right of the intersection is some commercial activity including an equipment supplier and a restaurant. The left of the intersection is very low in activity, with some trucks and palette storage.

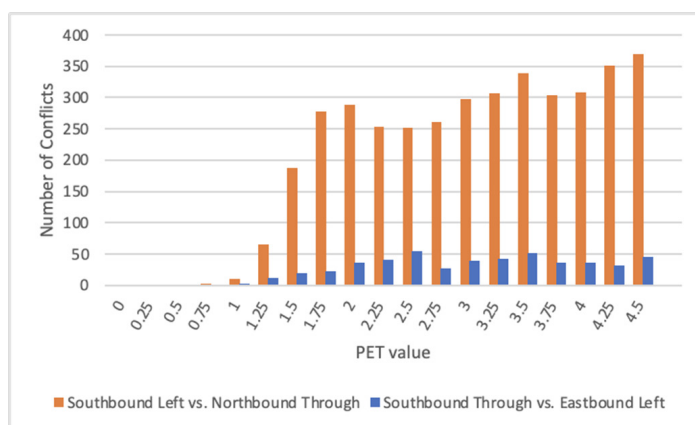
Figure 4. Number of conflicts observed by PET threshold value.

Figure 4 below shows the number of conflicts for the two scenarios with the largest number of interactions. Conflicts between other movements were not statistically significant and were therefore not included in this analysis. It is apparent that the movement pair with the highest frequency of conflicts is between southbound left turning vehicles and northbound through vehicles, as seen in Figure 5
